**Flood Control Project Maintenance
Levee Inspections**

Fall 2014 Levee Maintenance Deficiency Summary Report

Knights Landing Ridge Drainage District

Levee Inspection Report By Mile - Fall 2014

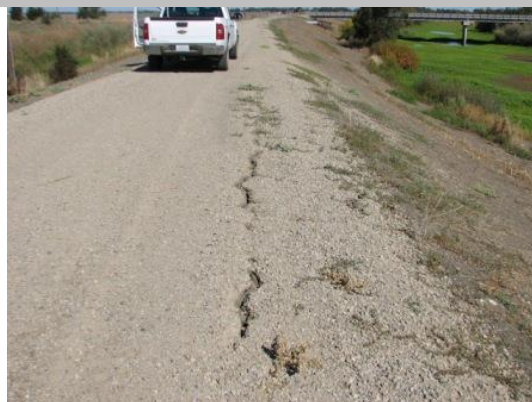
Photo 1 of 1 : FA_2014_NA0008_256_19_20141014_00003.jpg

LM Start	2.61	Rating **	A/W	Issue No.	19
LM End	2.61	Issue Type +	Ma	Location *	WS
Category	Earthen Levee			GPS Latitude/Longitude	
				Start	End
Item	Cracking			38.747218 °	38.747218 °
				-121.694450 °	-121.694450 °
DWR ID	DWR_NA0008_01 f _2013_19

Cracking along the waterside shoulder of the crown the length of 20 feet.
Fall 2013

Action/Comments					
Monitor and have inspected by geotechnical engineer. Inspector Comments: Cracks along crown and down waterside slope.

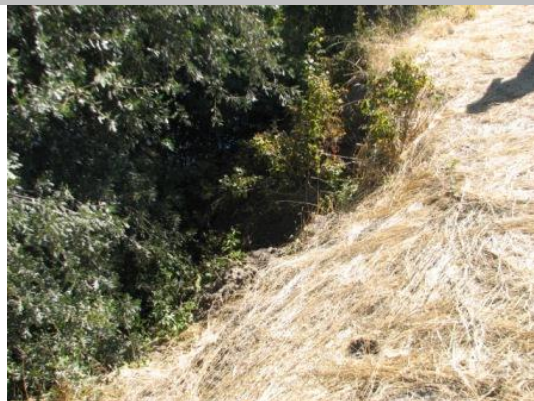
Photo 1 of 2 : FA_2014_NA0008_256_20_20141014_00004.jpg

LM Start	3.54	Rating **	M	Issue No.	20
LM End	3.54	Issue Type +	Ma	Location *	WS
Category	Earthen Levee			GPS Latitude/Longitude	
				Start	End
Item	Erosion / Bank Caving			38.759910 °	38.759910 °
				-121.696920 °	-121.696920 °
DWR ID	DWR_NA0008_01_f_2013_20				
Action/Comments					
Note and monitor erosion site.

Another view of the erosion cutting into the slope. Fall 2013

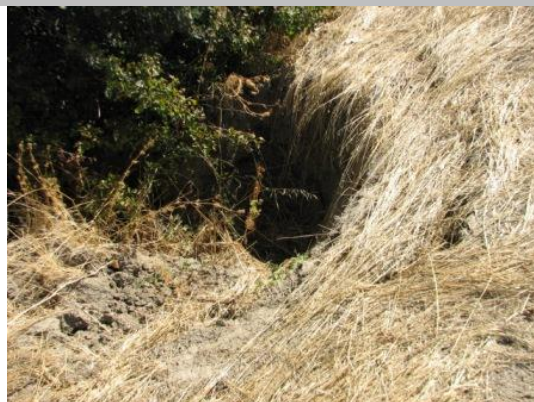
Photo 2 of 2 : FA_2014_NA0008_256_20_20141014_00005.jpg

Deep erosion at the bottom of the waterside slope 3-4 foot cut. Fall 2013

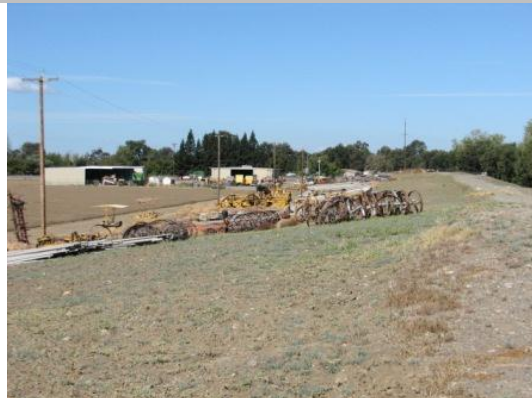
Photo 1 of 2 : FA_2014_NA0008_256_7_20141014_00001.jpg

LM Start	6.17	Rating **	M	Issue No.	7
LM End	6.41	Issue Type +	Ma	Location *	LS
Category	Earthen Levee			GPS Latitude/Longitude	
				Start	End
Item	Encroachments			38.790007 °	38.792433 °
				-121.723308 °	-121.726463 °
DWR ID	DWR_NA0008_01_s_2012_7				
Action/Comments					
Equipment

Equipment and irrigation pipe lays on the landside levee slope. Fall 2013

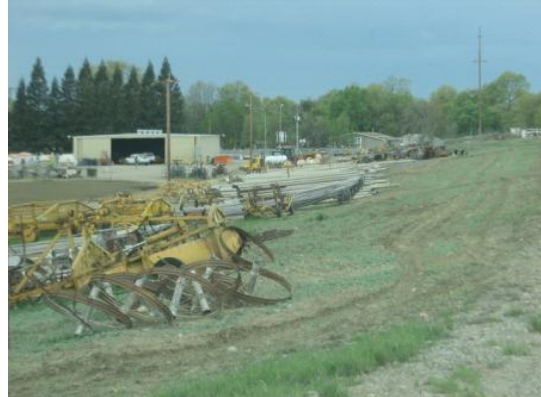
Photo 2 of 2 : FA_2014_NA0008_256_7_20141014_00002.jpg

A current view of the equipment on the levee slope. Spring 2014

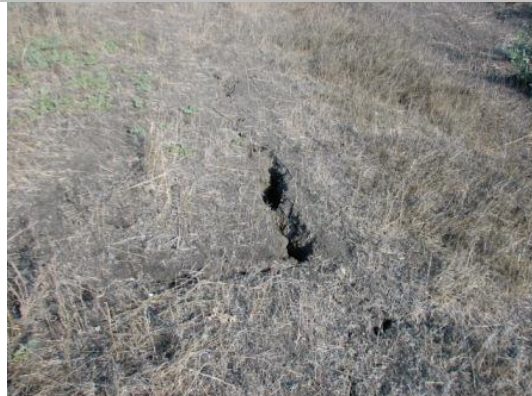
Photo 1 of 1 : FA_2014_NA0008_257_226_20141014_00006.jpg

LM Start	4.86	Rating **	A/W	Issue No.	226
LM End	4.88	Issue Type +	Ma	Location *	LS
Category	Earthen Levee			GPS Latitude/Longitude	
				Start	End
Item	Cracking			38.780858 °	38.781102 °
				-121.709093 °	-121.709385 °
DWR ID	DWR_NA0008_02_f_2013_226				
Action/Comments					
Monitor and have inspected by geotechnical engineer.

Cracking on the landside is 3-4 inches wide and 12 inches deep. Fall 2013

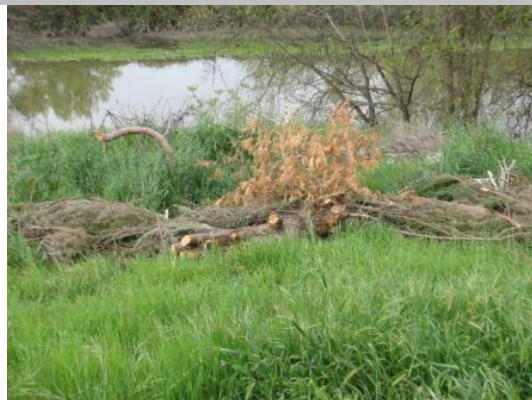
Photo 1 of 1 : FA_2014_NA0008_257_12_20141014_00003.jpg

Action/Comments					
Debris

A debris pile is on the waterside levee slope. Spring 2014

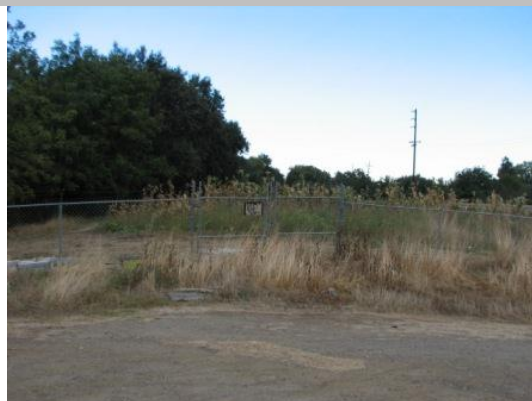
Photo 1 of 2 : FA_2014_NA0008_257_1_20141014_00001.jpg

LM Start	6.05	Rating **	M	Issue No.	1
LM End	6.12	Issue Type +	En	Location *	LS
Category	Earthen Levee			GPS Latitude/Longitude	
				Start	End
Item	Encroachments			38.792735 °	38.792735 °
				-121.724092 °	-121.724092 °
DWR ID	DWR_NA0008_02_s_2012_1				
Action/Comments					
Crops					
Inspector Comments: No access; strawberries are being grown					
landside levee slope and crown

Strawberry patch on the levee crown has added other crops on the crown. Fall 2013

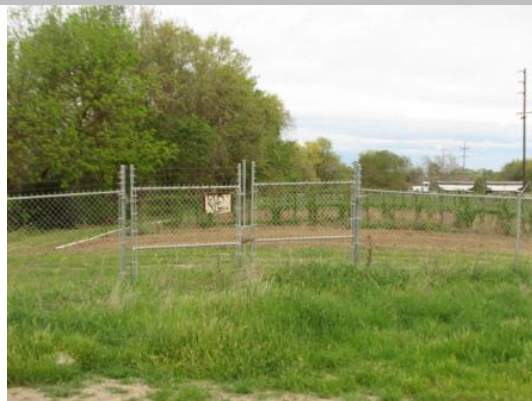
Photo 2 of 2 : FA_2014_NA0008_257_1_20141014_00002.jpg

Crops (strawberries and berries vines) are planted on the crown with a fence blocking access. Spring 2014
